**Climate Proofing Housing Landscapes:  
Monitoring Report 2**

**June 2016 to September 2016**

**Authors: Connop, S., Clough, J., Gunawardena, D. and Nash, C.**

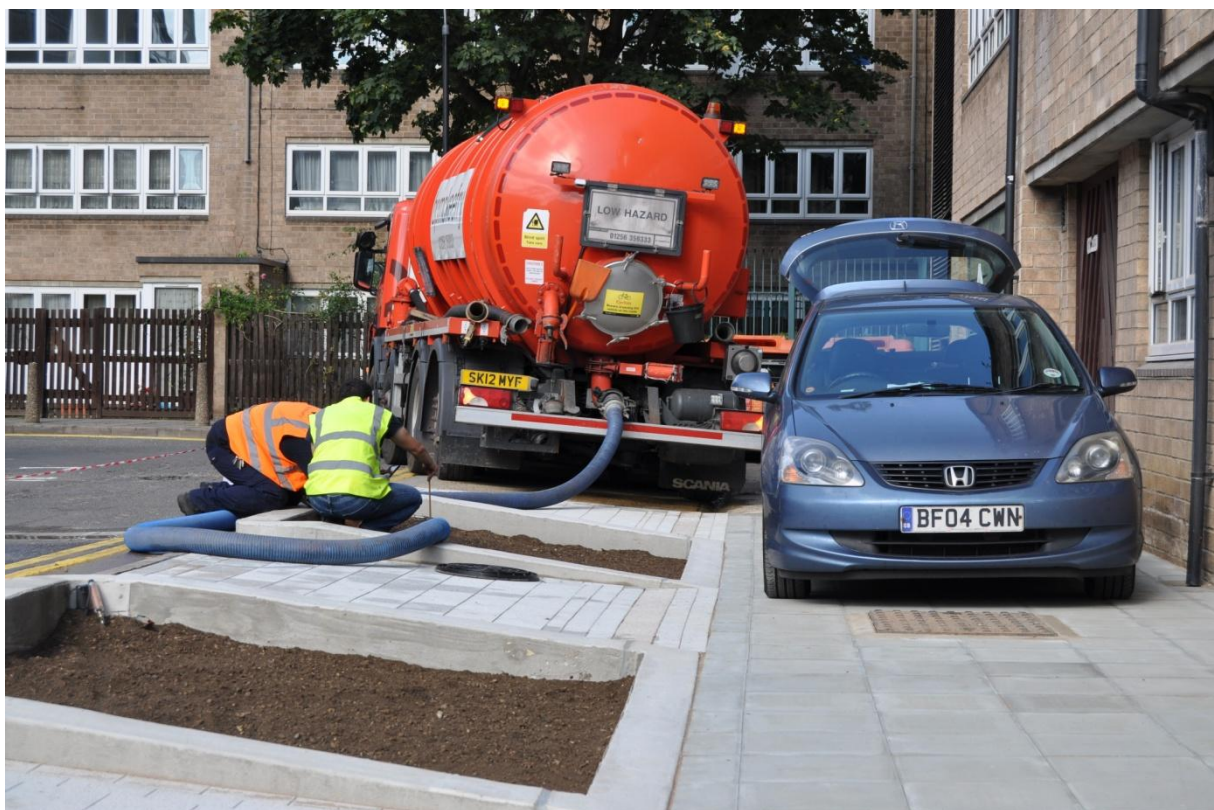
**Figure 36. Water tanker delivering 6000 Litres of non-potable water for the storm simulation event at Cheeseman Terrace Estate.** Storm simulation was carried out over the course of an hour on the 23rd September 2016.

In order to create a simulation of a 1 in 5 year event it was therefore necessary to pump 5580 L of water into the swale over the course of an hour. In order to achieve this it was necessary to hire a tanker capable of transporting and delivering such a quantity of water (Figure 36).

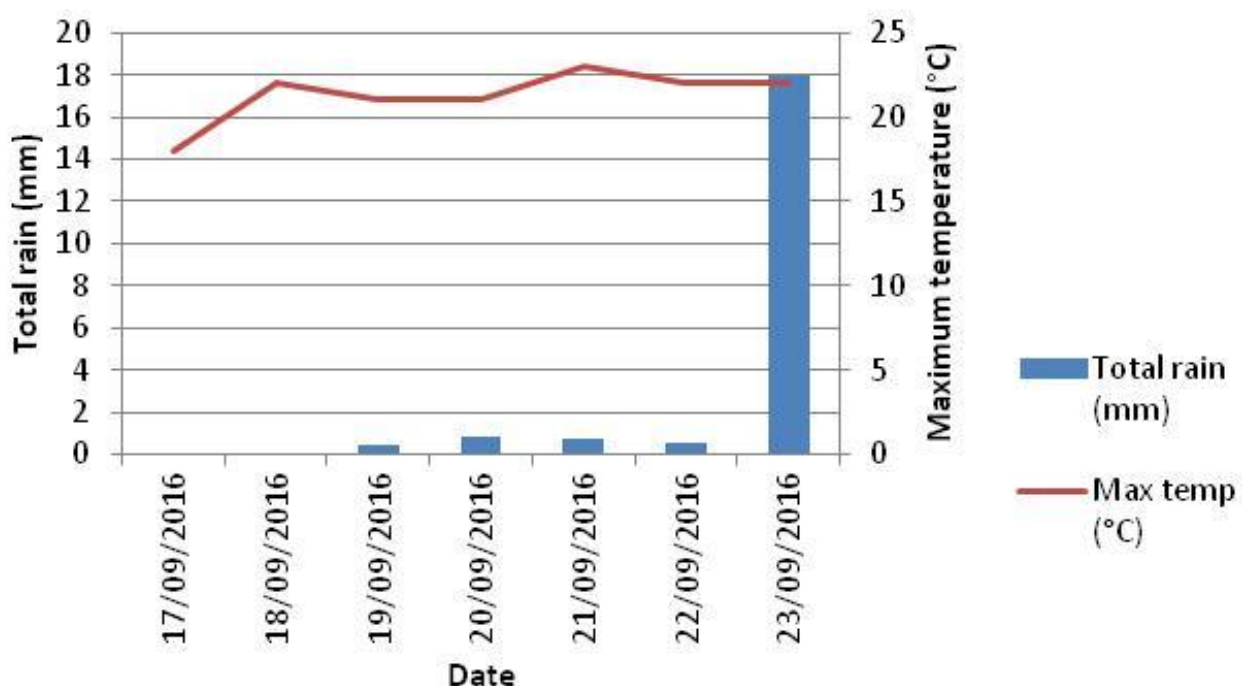
**Figure 37. Weather conditions in Hammersmith preceding the storm event simulation at the Cheeseman Terrace Estate rain gardens.** At the time of preparing this report no download had been carried out of the RKH or Henrietta House weather stations. As such, data for the preceding weather was taken from World-wide Weather Online (2016). Rain on the 23rd represents that for the rain simulation event. No other rain fell on this day at Hammersmith.

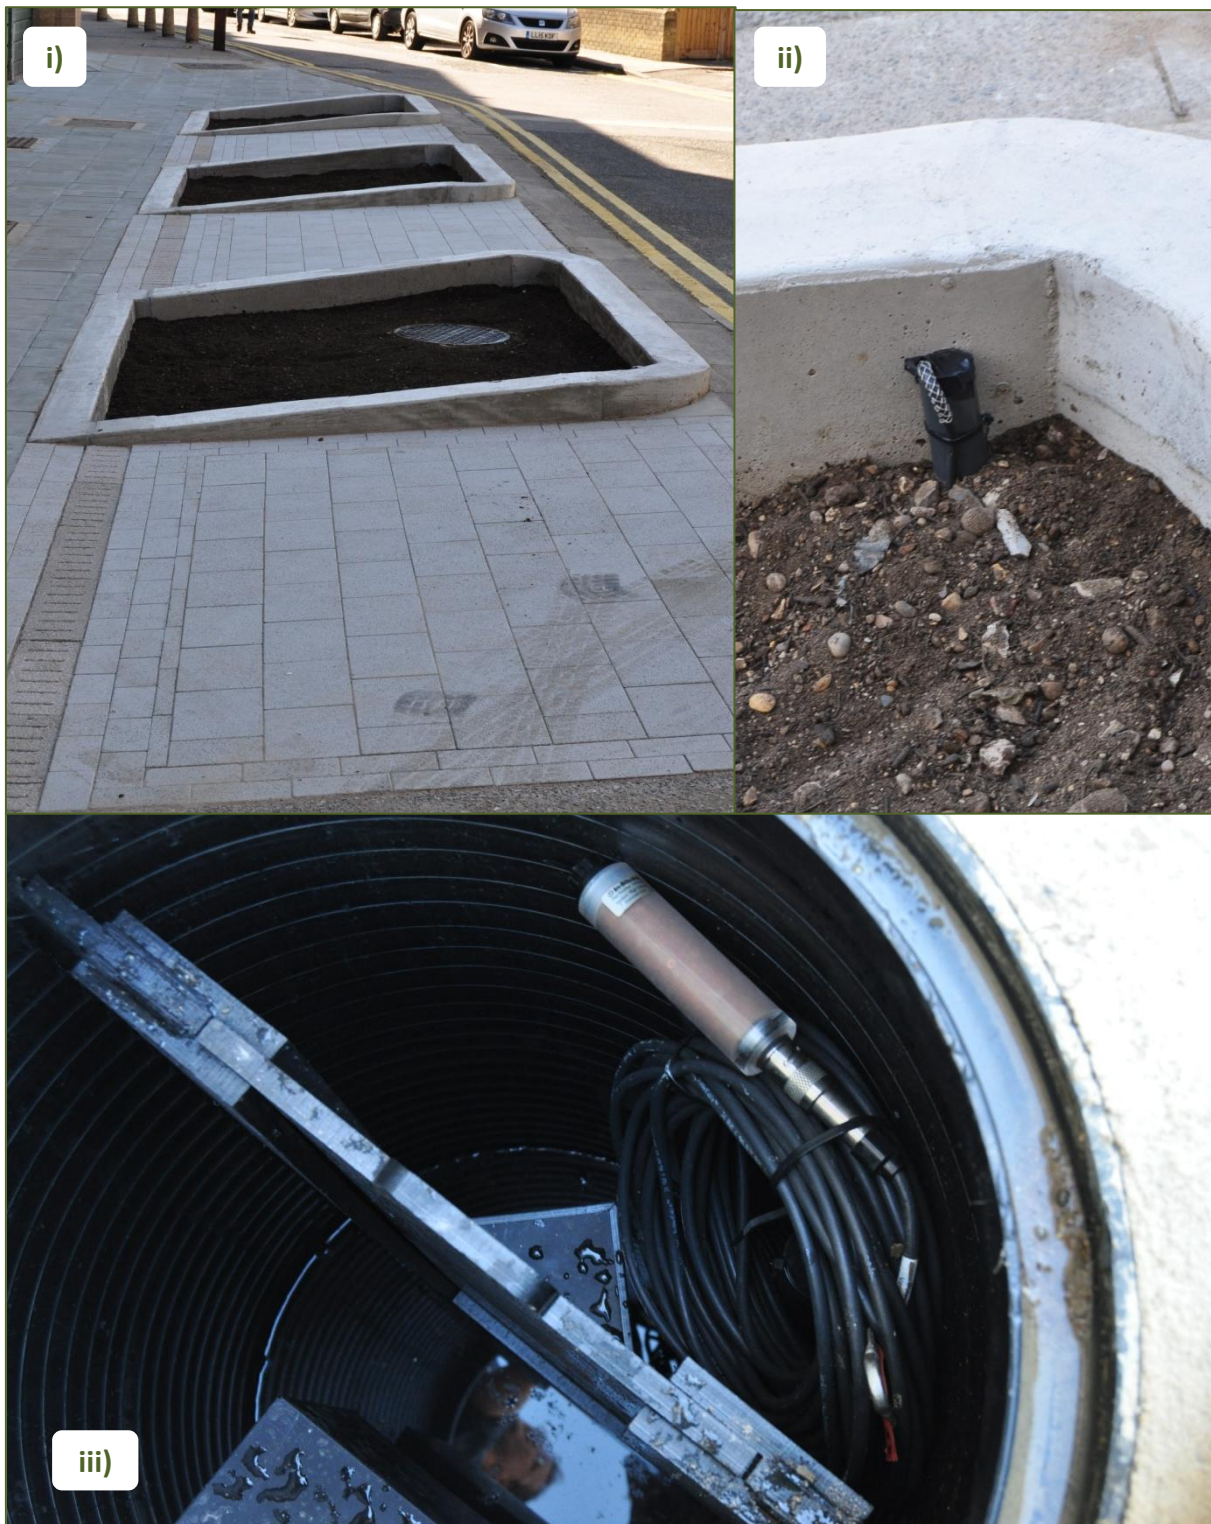
**Figure 38. Images from the storm simulation event at the Sun Road rain gardens, Cheeseman Terrace Estate, 23rd September 2016.** Images show i) Cheeseman Terrace Estate rain gardens before rain simulation; ii) pressure sensor installed in the corner of one of the rain gardens; iii) pressure sensor installed in the control flow chamber in the outlet from the rain garden.

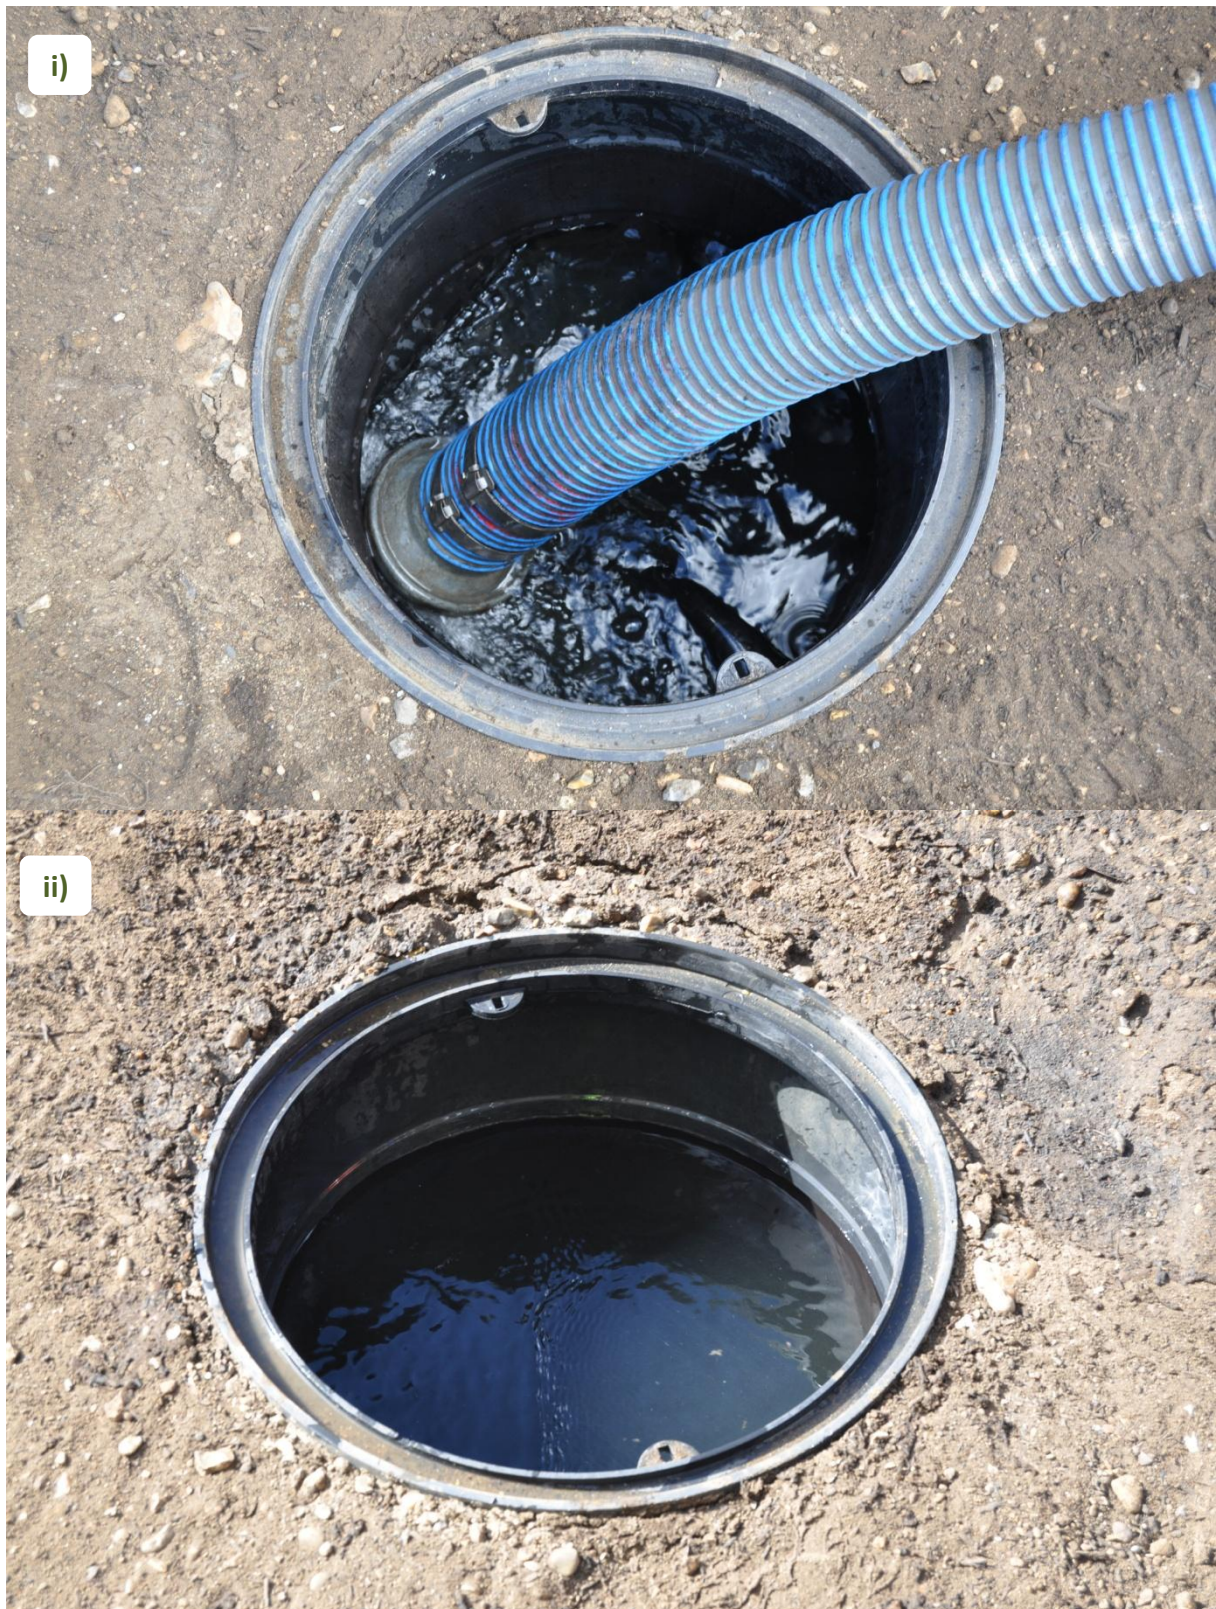
**Figure 39. Images from the storm simulation event at the Sun Road rain gardens, Cheeseman Terrace Estate, 23rd September 2016. Images show i) water being pumped into the inspection chamber of the rain garden; ii) inlet chamber full after the stormwater was pumped in.**

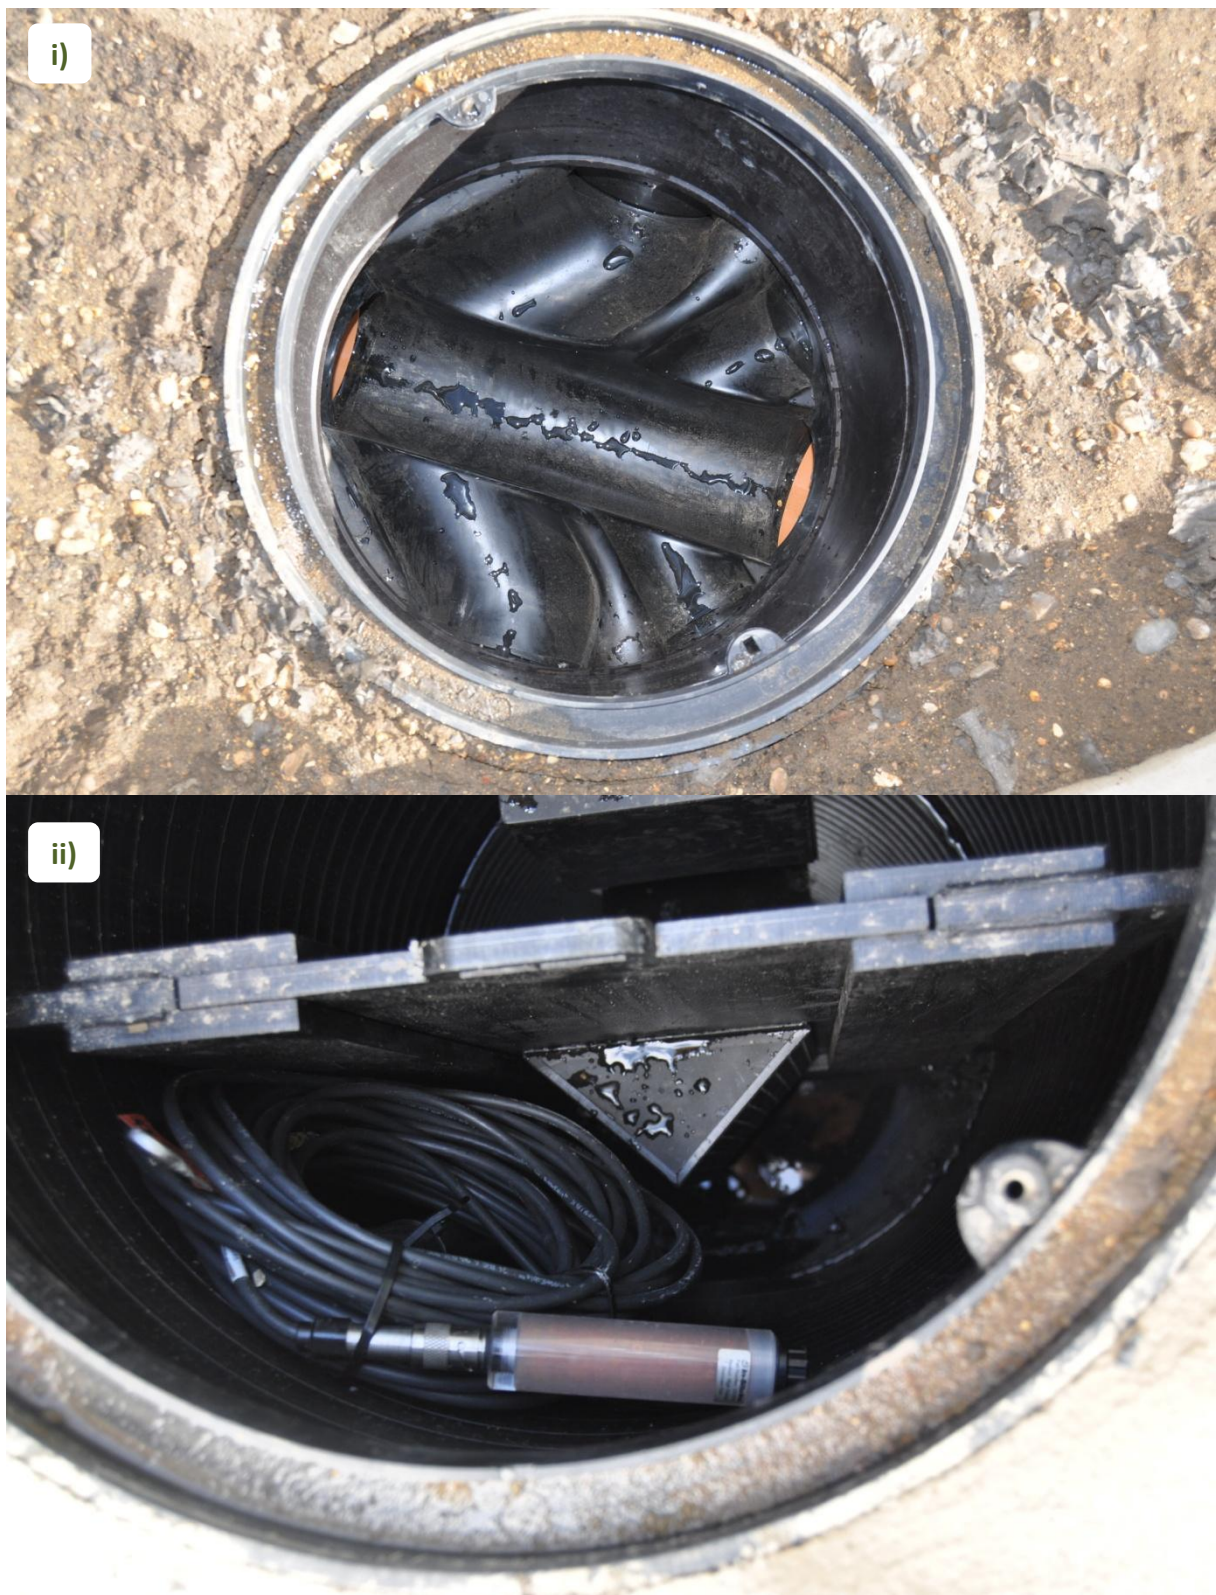
**Figure 40. Images from the storm simulation event at the Sun Road rain gardens, Cheeseman Terrace Estate, 23rd September 2016. Images show i) the rain garden inspection chamber 30 minutes after the last of the 6,000 Litres of water was released and ii) the control flow chamber showing no release of water from the rain gardens following the 1 in 5 year storm event simulation.**

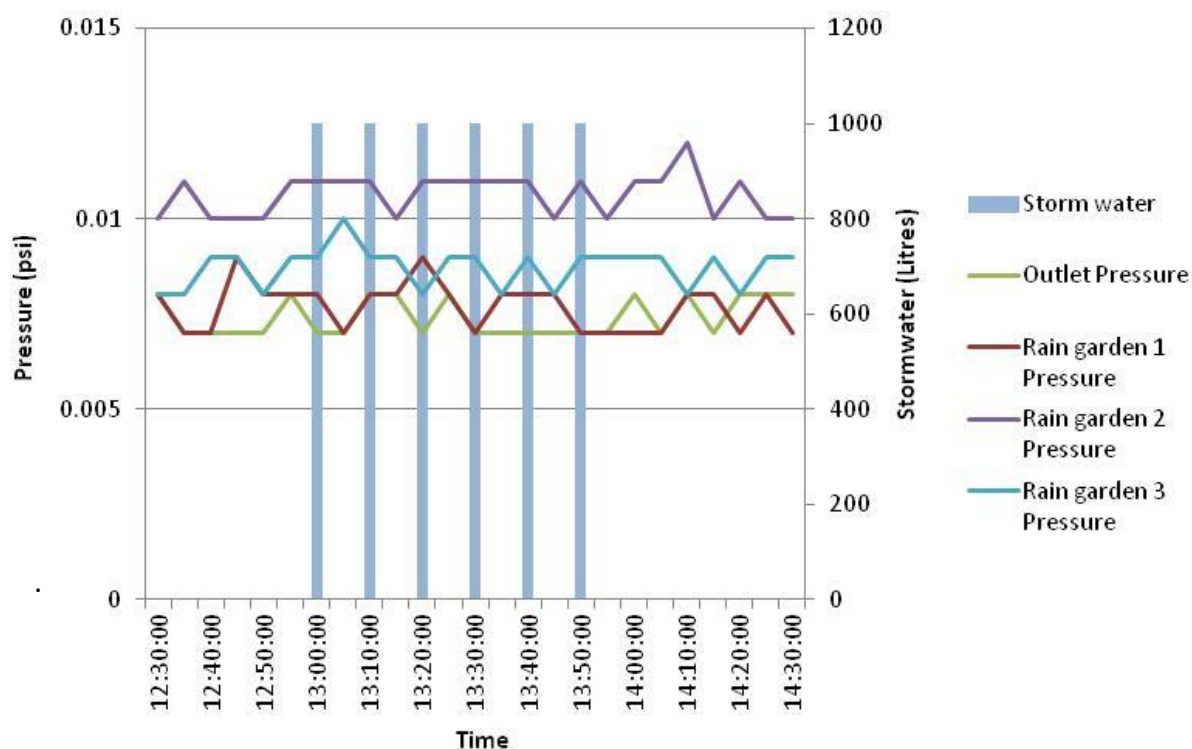
**Figure 42. Pressure sensor data from 1 in 5 year storm simulation event at the Sun Road rain gardens, Cheeseman Terrace Estate, London Borough of Hammersmith and Fulham.** Blue bars represent the times when 1000L of water were pumped into the swale, the red, green, purple and light blue lines represent the readings of pressure sensors buried within each rain garden and in the control flow outlet chamber to measure changes in the water table.

standing water to disappear from the rain garden after the testing provided a good assessment of infiltration times during the event (although it is not possible to establish whether this was due to basal infiltration or lateral infiltration). Visual assessment of the rain gardens following the study indicated that no standing water was visible within the rain garden inspection chambers 30 minutes after the storm event. In addition, no data was obtained from the pressure sensors buried in each of the rain gardens indicating that the rain garden soil did not become saturated and that there was additional capacity that could be filled (Figure 42).

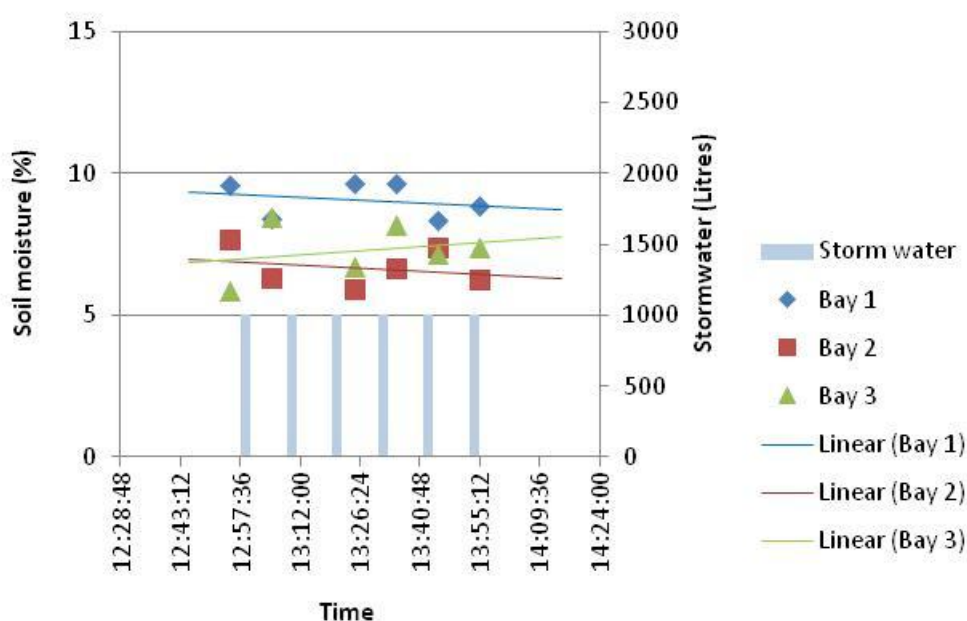
**Figure 43. Surface soil moisture data from 1 in 5 year storm simulation event at the Sun Road rain gardens, Cheeseman Terrace Estate, London Borough of Hammersmith and Fulham.** Blue bars represent the times when 1000L of water were pumped into the swale. The scatterplot data represents the average of five soil moisture readings taken within each of the three rain gardens before, during and after each 1000 L of stormwater was introduced.

Following the initiation of the storm event, the leveloggers recorded no additional pressure above the baseline level. It is likely that the main reason for this pattern was due to the stormwater being introduced to the rain gardens through the inspection chambers (as would occur from roadside run off), rather than some also being introduced on top of the rain garden to mimic rainfall patterns that would occur during a natural storm event. As such, all infiltration would have occurred below the level of the pressure gauges. Nevertheless, no evidence of backing up of the rain gardens was provided by the pressure sensors. This indicated that the rain gardens were able to retain and infiltrate all of the stormwater introduced below the height of the gauges and thus additional storage capacity would have been available at the top of the rain gardens were a natural rain event to have occurred with larger rain volumes than that simulated in this rain event. This finding was also supported by the lack of any significant increases recorded by the soil moisture sensors during or after the rain simulation (Figure 43).

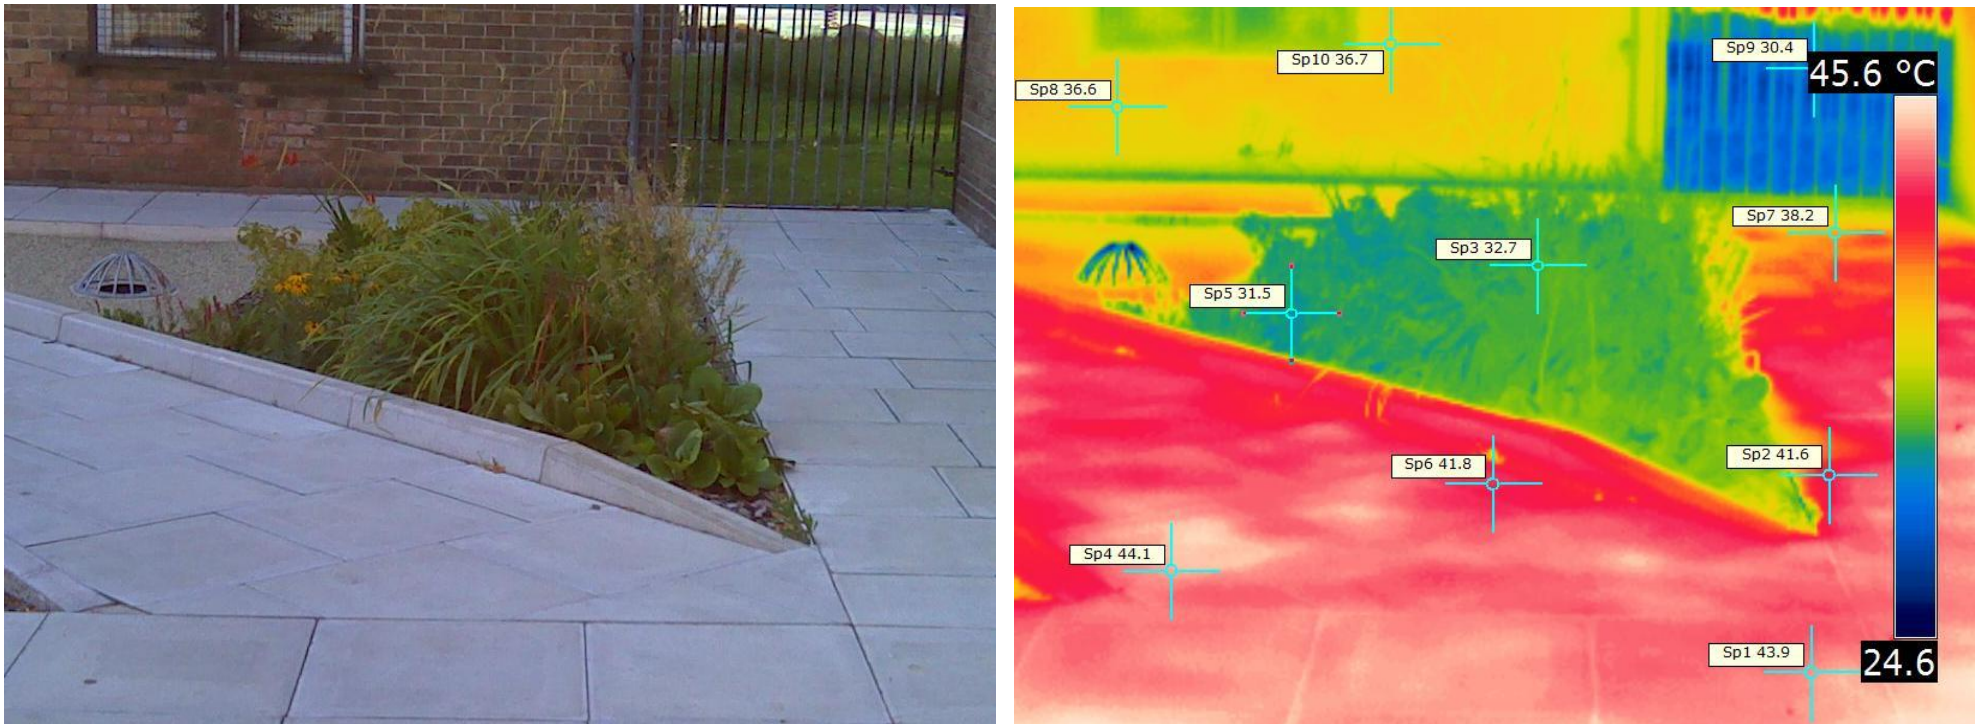
**Figure 51. Photo and infrared image of rain garden at Queen Caroline Estate 19th September 2016.** Infrared image reveals a temperature difference of 21.0 °C between the hottest and coolest areas within the field of view. A FLIR QuickReport spotmeter was used to identify individual temperatures within the field of view. Hottest temperatures (>40 °C) were associated with the paved areas surrounding the rain garden. These areas were recorded as being substantially hotter than the maximum daily temperature recorded by the nearby weather station (32.6 °C). Coolest temperatures were associated with the tall vegetated areas of the rain garden (with temperatures from 31.5 °C to 32.7 °C). The surrounding walls were also hot (36.6 °C and 36.7 °C).

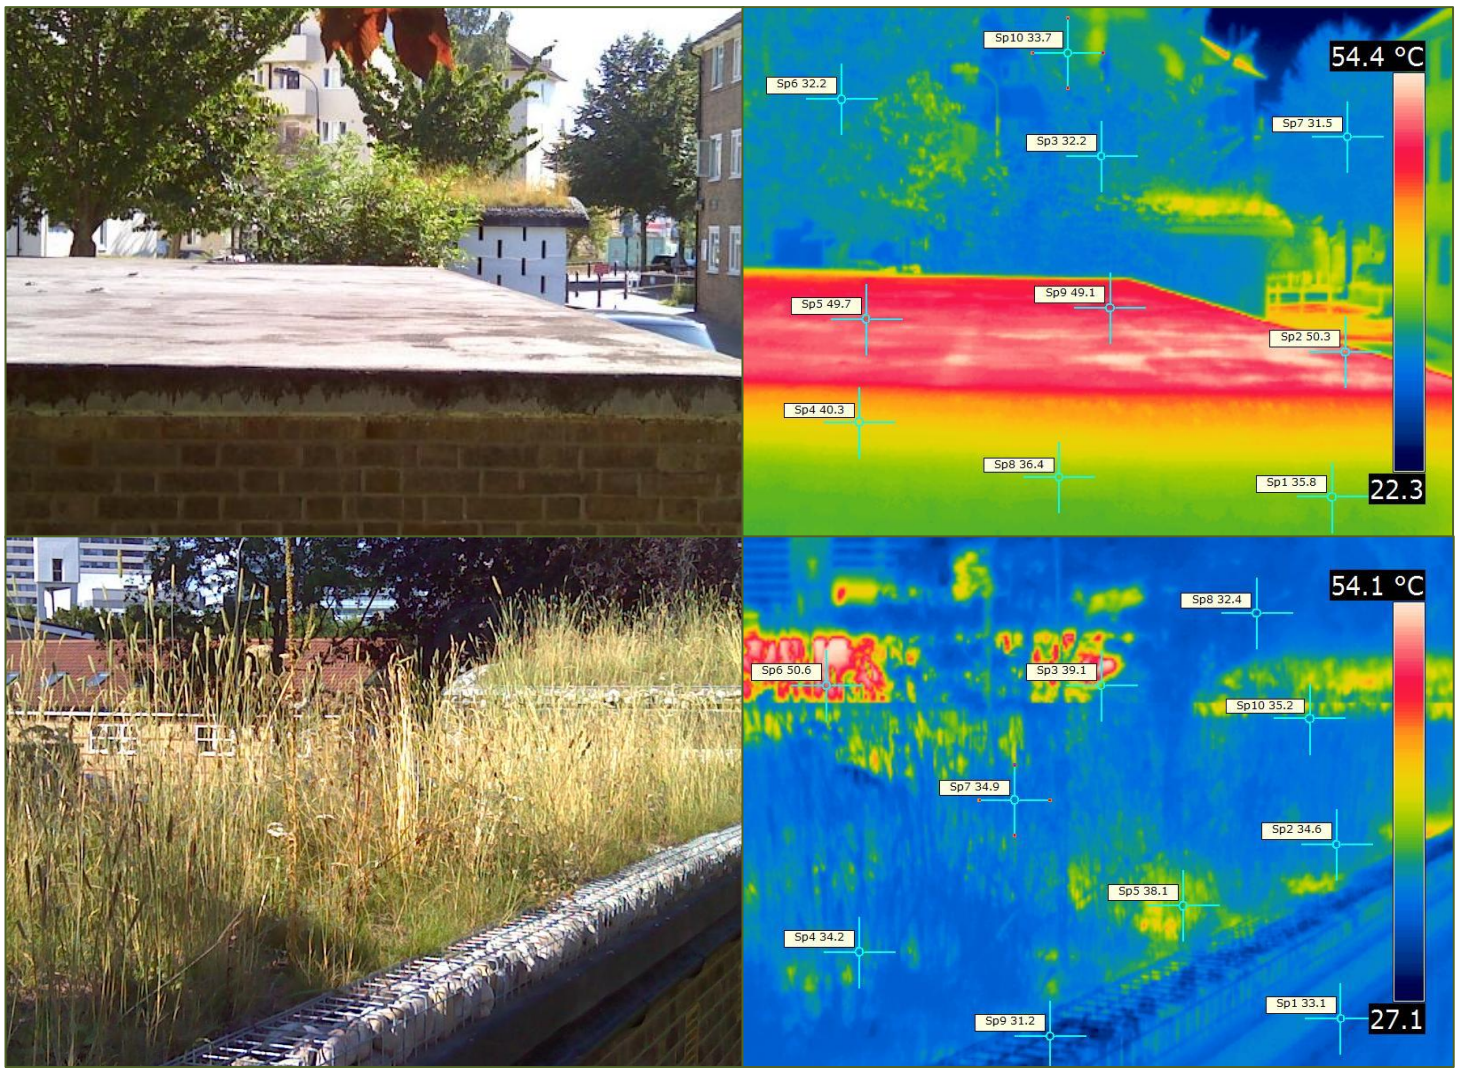
**Figure 52. Photo and infrared image of standard and greened pramshed roofs, 19th July 2016.** Infrared image reveals a temperature difference of 32.1 °C between the hottest and coolest areas within the fields of view. A FLIR QuickReport spotmeter was used to identify individual temperatures within the fields of view. Hottest temperatures (>49 °C) were associated with the standard pramshed roof areas. These areas were recorded as being substantially hotter than the maximum daily temperature recorded by the nearby weather station (32.6 °C). Coolest temperatures were associated with the tall vegetated areas of the greened pramshed roofs (with temperatures from 34.2 °C to 34.9 °C).

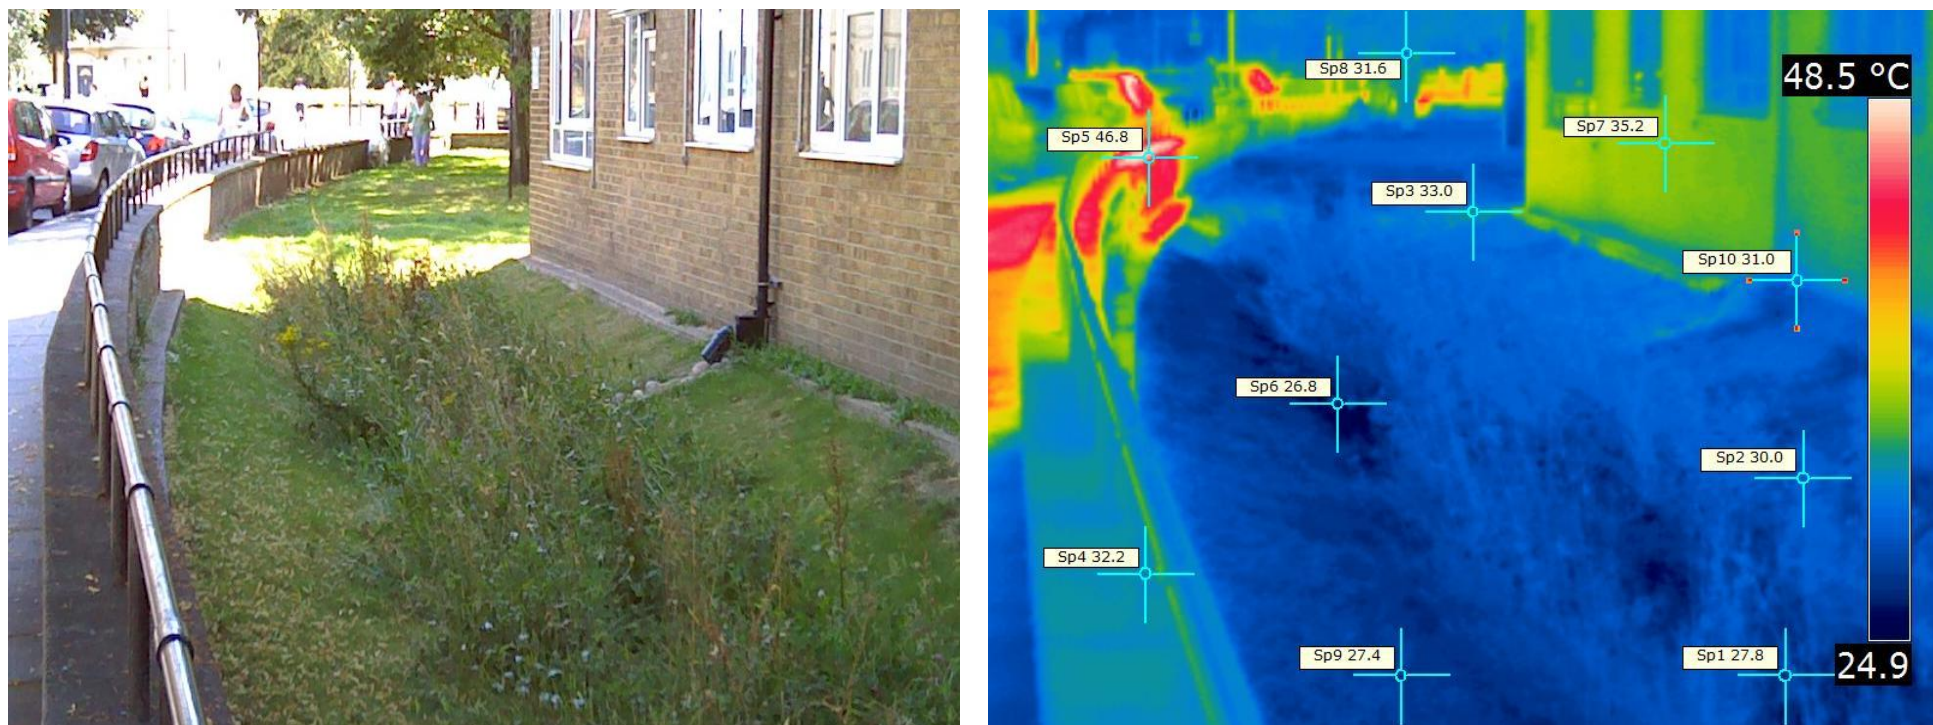
**Figure 53. Photo and infrared image of Beatrice House Swale, 19th July 2016.** Infrared image reveals a temperature difference of 23.6 °C between the hottest and coolest areas within the field of view. A FLIR QuickReport spotmeter was used to identify individual temperatures within the field of view. Hottest temperatures (>35 °C) were associated with the walls of Beatrice House surrounding the rain garden. These areas were recorded as being hotter than the maximum daily temperature recorded by the nearby weather station (32.6 °C). Coolest temperatures were associated with the tall vegetated areas of the swale (with temperatures from 26.8 °C to 30.0 °C).

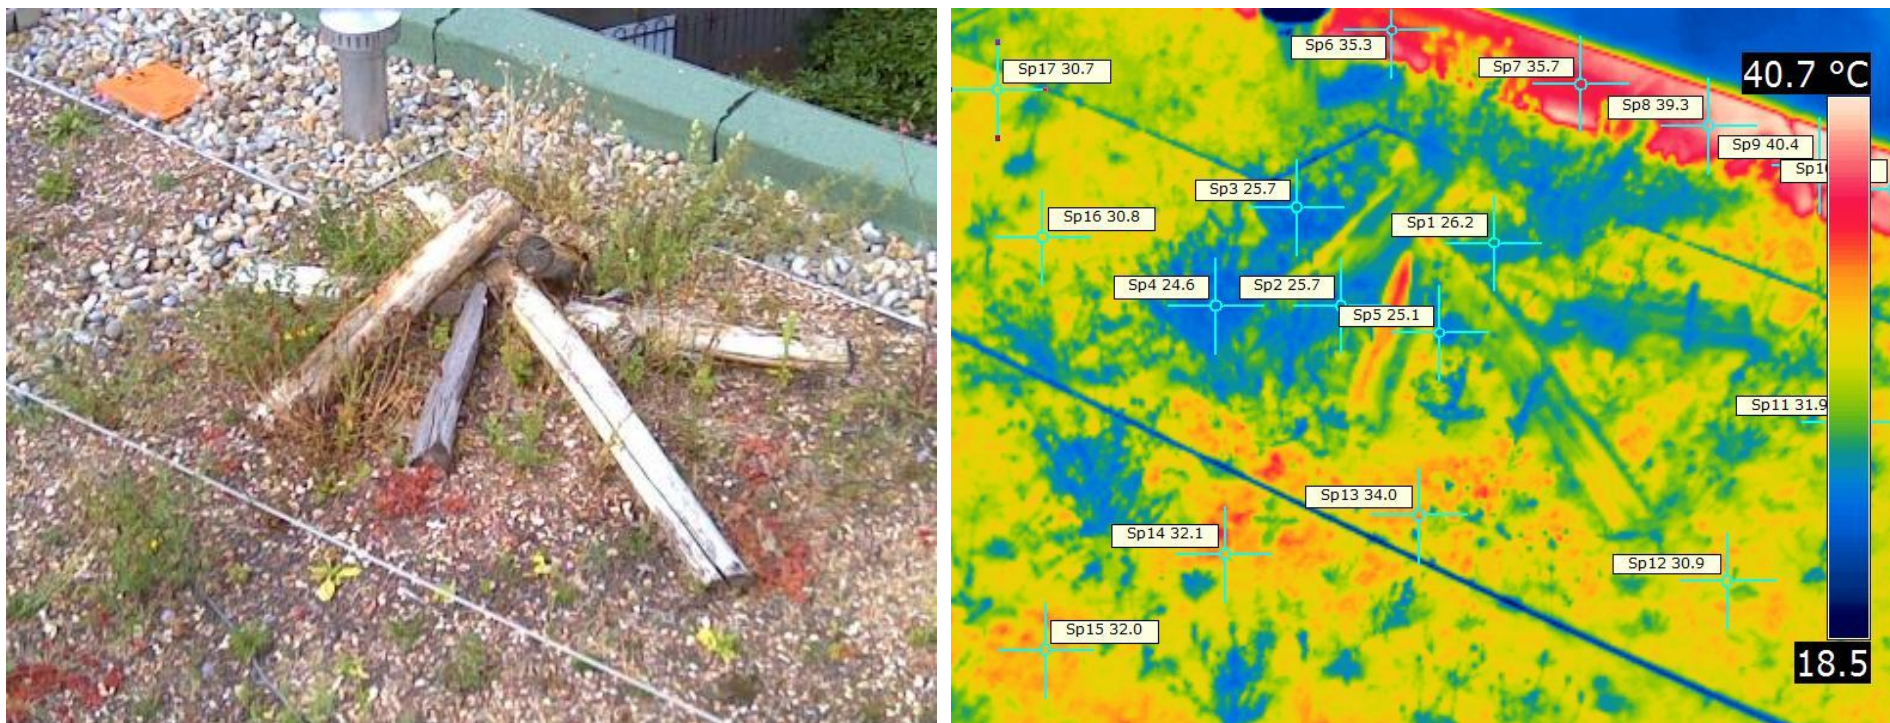
**Figure 55. Photo and infrared image of habitat pile on the Richard Knight House green roof 27th July 2016.** Infrared image reveals a temperature difference of 22.2 °C between the hottest and coolest areas within the field of view. A FLIR QuickReport spotmeter was used to identify individual temperatures within the field of view. Hottest temperatures (>35 °C) were associated with the non-greened edges of the flat roof. These areas were recorded as being hotter than the maximum daily temperature recorded by the nearby weather station (24.3 °C). Temperatures on sparsely vegetated areas of the greened roof were substantially lower than the roof edges (30.9 to 34.0 °C). The coolest areas were associated with the log habitat pile, this area appeared to provide refuge for the wildflowers and shading on the substrate. Temperatures around the log pile were between 24.6 to 26.2 °C providing evidence for the additional benefits of habitat piles on green roofs.

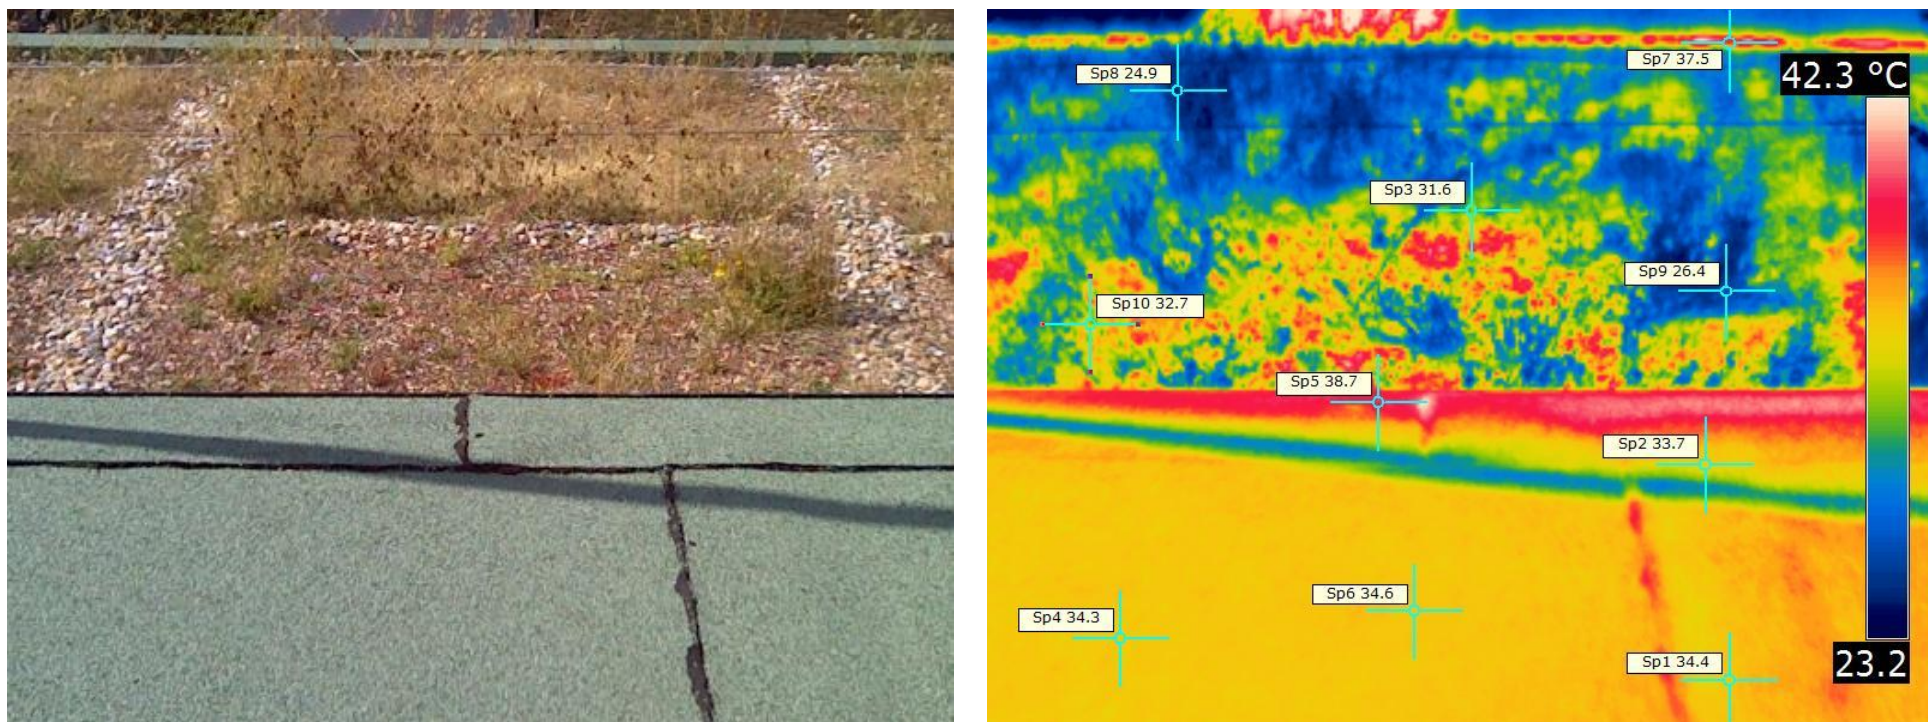
**Figure 57. Photo and infrared image of green roof and neighbouring standard roof on Richard Knight House 27th July 2016.** Infrared image reveals a temperature difference of 19.1 °C between the hottest and coolest areas within the field of view. A FLIR QuickReport spotmeter was used to identify individual temperatures within the field of view. Hottest temperatures (>33 °C) were associated with the non-greened areas of the flat roof. These areas were recorded as being hotter than the maximum daily temperature recorded by the nearby weather station (24.3 °C). Temperatures on sparsely vegetated areas of the greened roof were slightly lower than the non-greened roof area (31.6 to 32.7 °C). The coolest areas were associated with the vegetated areas of the green roof (24.9 to 26.4 °C).

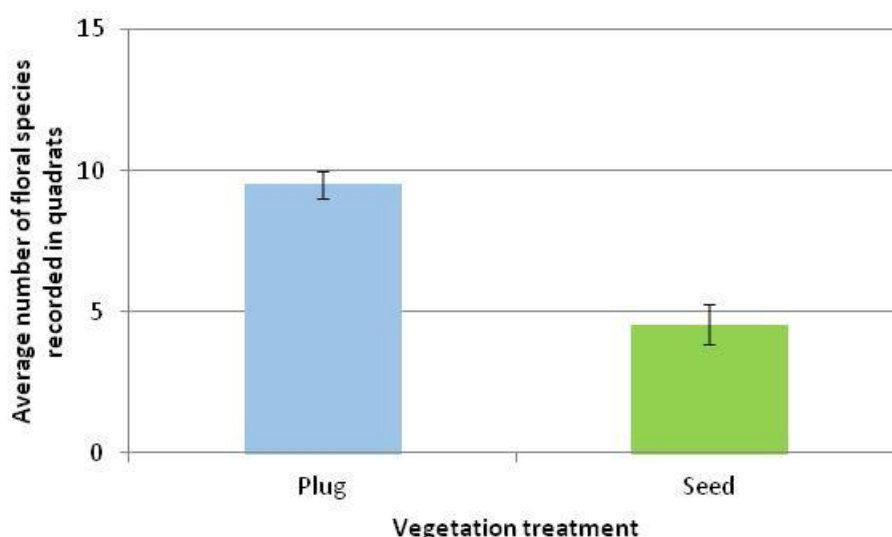
**Figure 61. Average floral diversity on the Richard Knight House green roof, 24th August 2016.** Averages are calculated on the number of floral species recorded in 18 quadrats for each of two treatment areas (plug planted vs seeded vegetation). Error bars represent standard error of the mean.

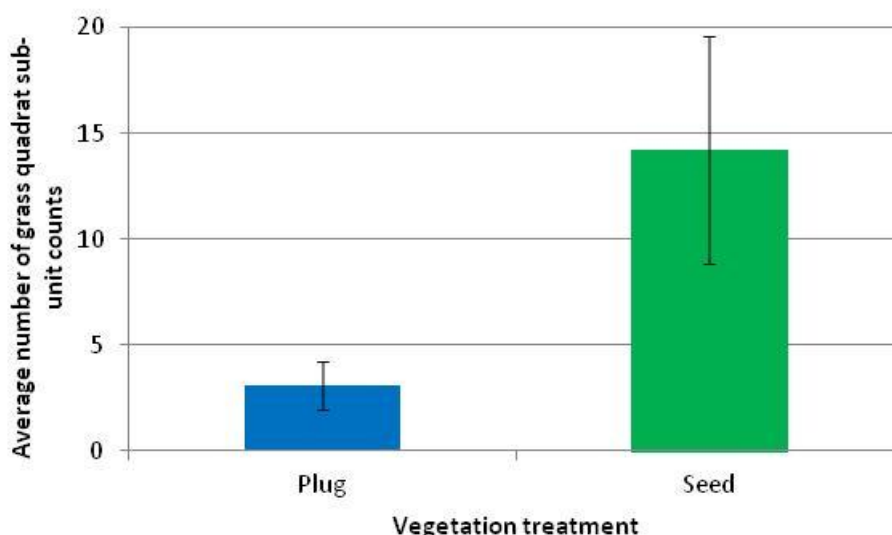
**Figure 63. Average number of grass counts in quadrat sub-units on the Richard Knight House green roof experimental plots, 24th August 2016.** Averages are calculated on the total number of records of all grass species within each quadrat within each experimental plot for 18 quadrats for each of two treatments (plug planted vs seeded vegetation). Error bars represent standard error of the mean.

Similarly to the previous survey, a greater grass cover was recorded on the seeded plots than on the plug planted plots (Figure 63). However, grass cover on seeded plots had reduced substantially by the time of this second survey (from a 97.6 squares per quadrat average in July to 14.2 in August). This was indicative of how susceptible green roof grasses tend to be to the typical drought conditions experienced on green roofs in the UK during the summer

months. A Mann-Whitney U Exact two-tailed test demonstrated that this difference between treatments was no longer significant ( $p = 0.217$ ).

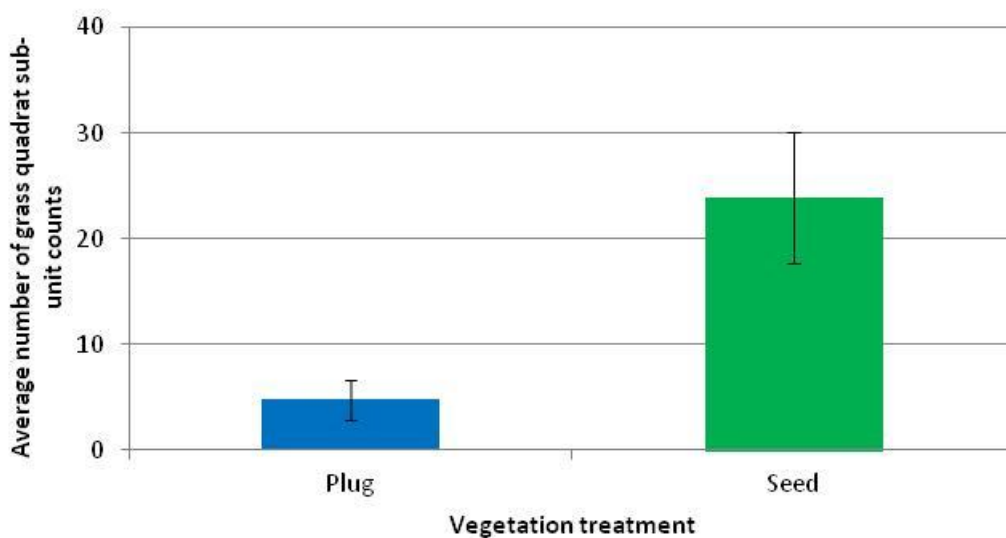
**Figure 66. Average number of grass counts in quadrat sub-units on the Richard Knight House green roof experimental plots, 22nd September 2016.** Averages are calculated on the total number of records of all grass species within each quadrat within each experimental plot for 18 quadrats for each of two treatments (plug planted vs seeded vegetation). Error bars represent standard error of the mean.

Similarly to the previous survey, a greater grass cover was recorded on the seeded plots than on the plug planted plots (Figure 66). Grass cover on seeded plots had increased slightly since the time of the second survey (from a 14.2 squares per quadrat average in August to 23.9 in September) but still remain substantially lower than the July average (97.6). Presumably this slight increase was indicative of the slightly cooler and damper conditions in September meaning that the grasses were less drought-stressed and so able to recover slightly. A Mann-Whitney U Exact two-tailed test demonstrated that this difference between treatments was significant again ( $p = 0.012$ ).

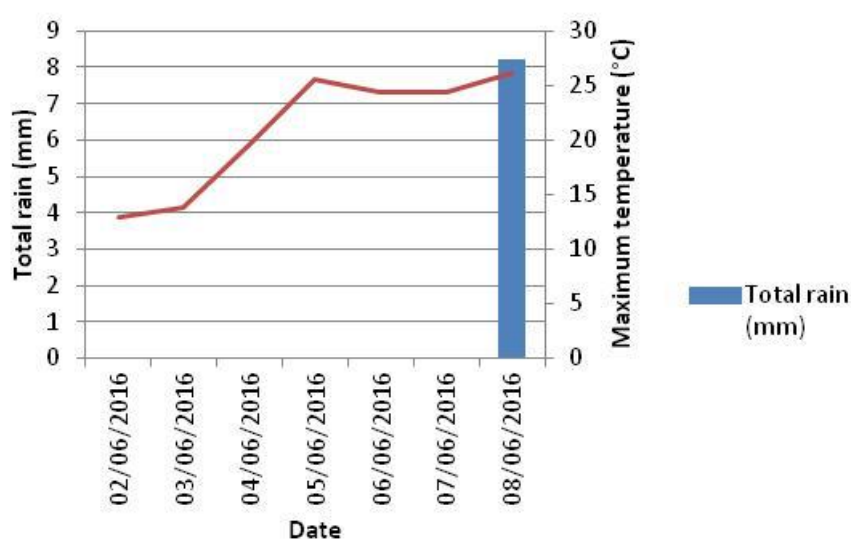
**Figure 70. Prevailing weather conditions preceding one of the five largest rain events at Queen Caroline Estate, Hammersmith.** Rain event was 8.2 mm on 8th June 2016.

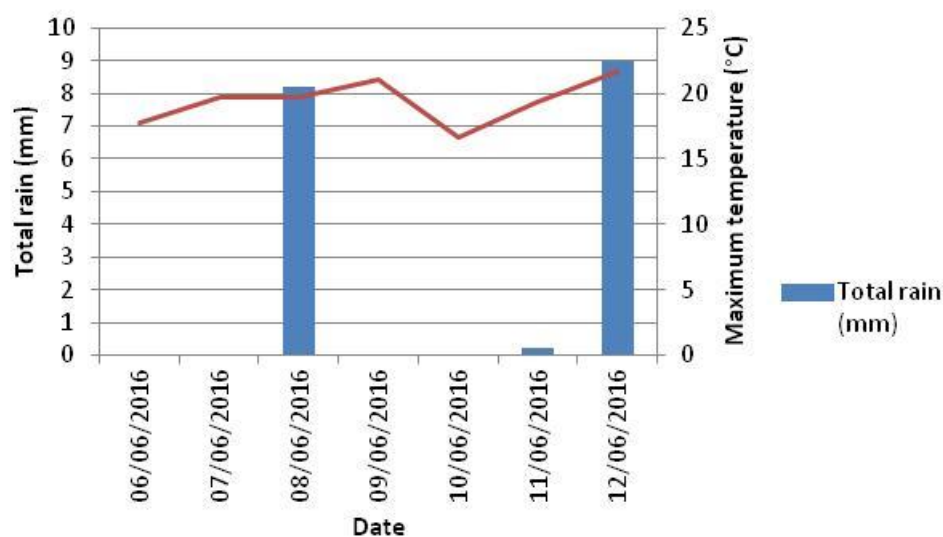
**Figure 72. Prevailing weather conditions preceding one of the five largest rain events at Queen Caroline Estate, Hammersmith.** Rain event was 9 mm on 12th June 2016.

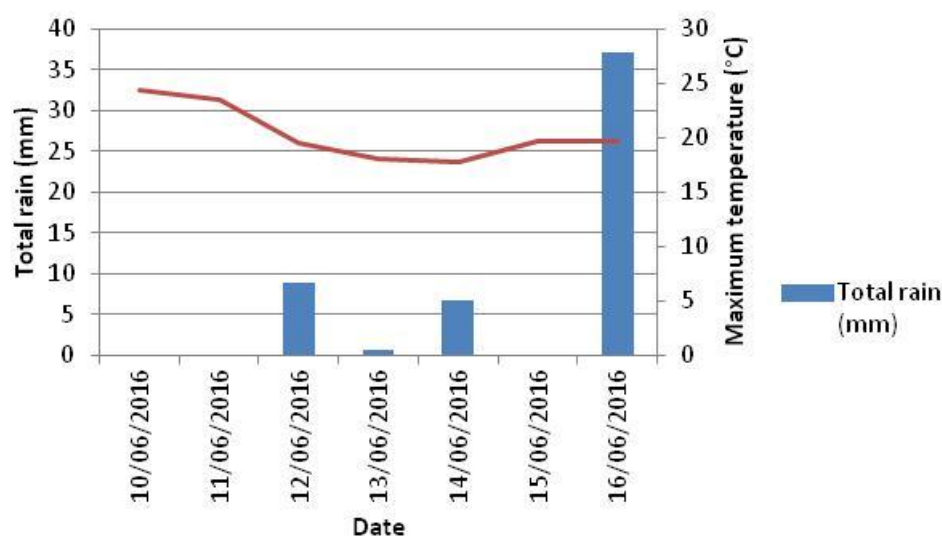
**Figure 74. Prevailing weather conditions preceding one of the five largest rain events at Queen Caroline Estate, Hammersmith.** Rain event was 37.2 mm on 16th June 2016.

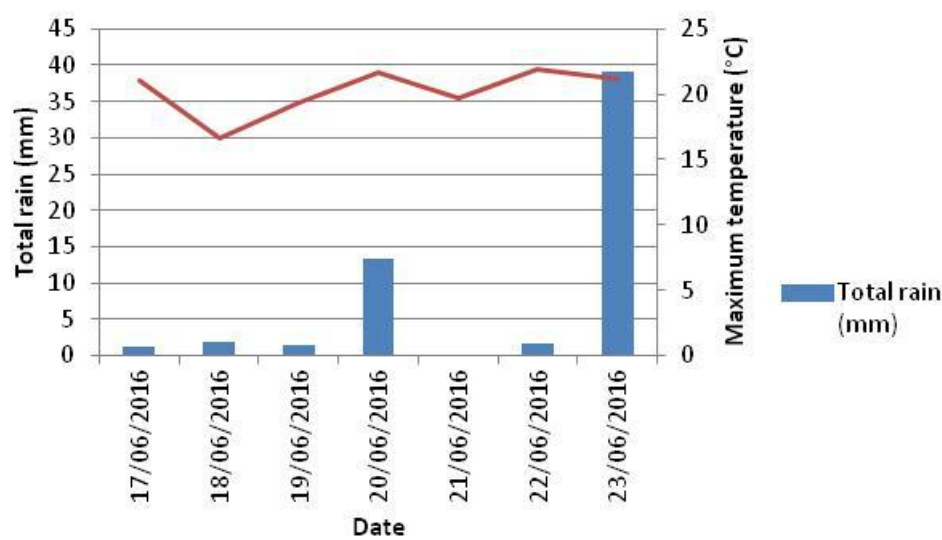
**Figure 78. Prevailing weather conditions preceding one of the five largest rain events at Queen Caroline Estate, Hammersmith.** Rain event was 39 mm on 23rd June 2016.
